MRC Model Railroad Transistor Throttle Repair

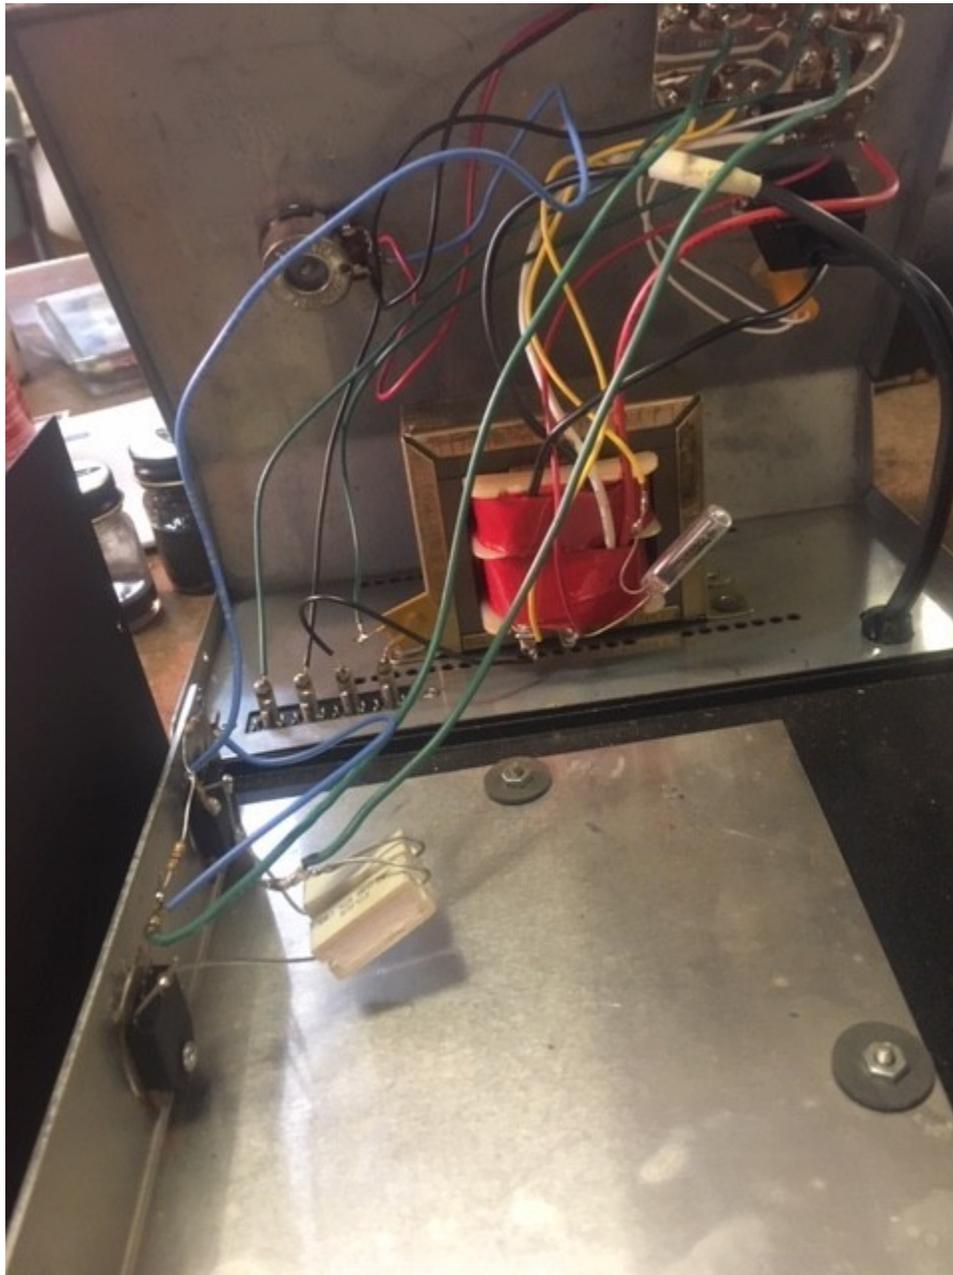
Figure 2: MRC6200 - Circuitry Layout

Re the above photo: The MRC6200 is a 50W throttle with two Darlington TIP121 transistors mounted on an Aluminum heat sink (at left in photo). There are no electrolytic capacitors so the output DC voltage is unfiltered, 60 cycle, AC.

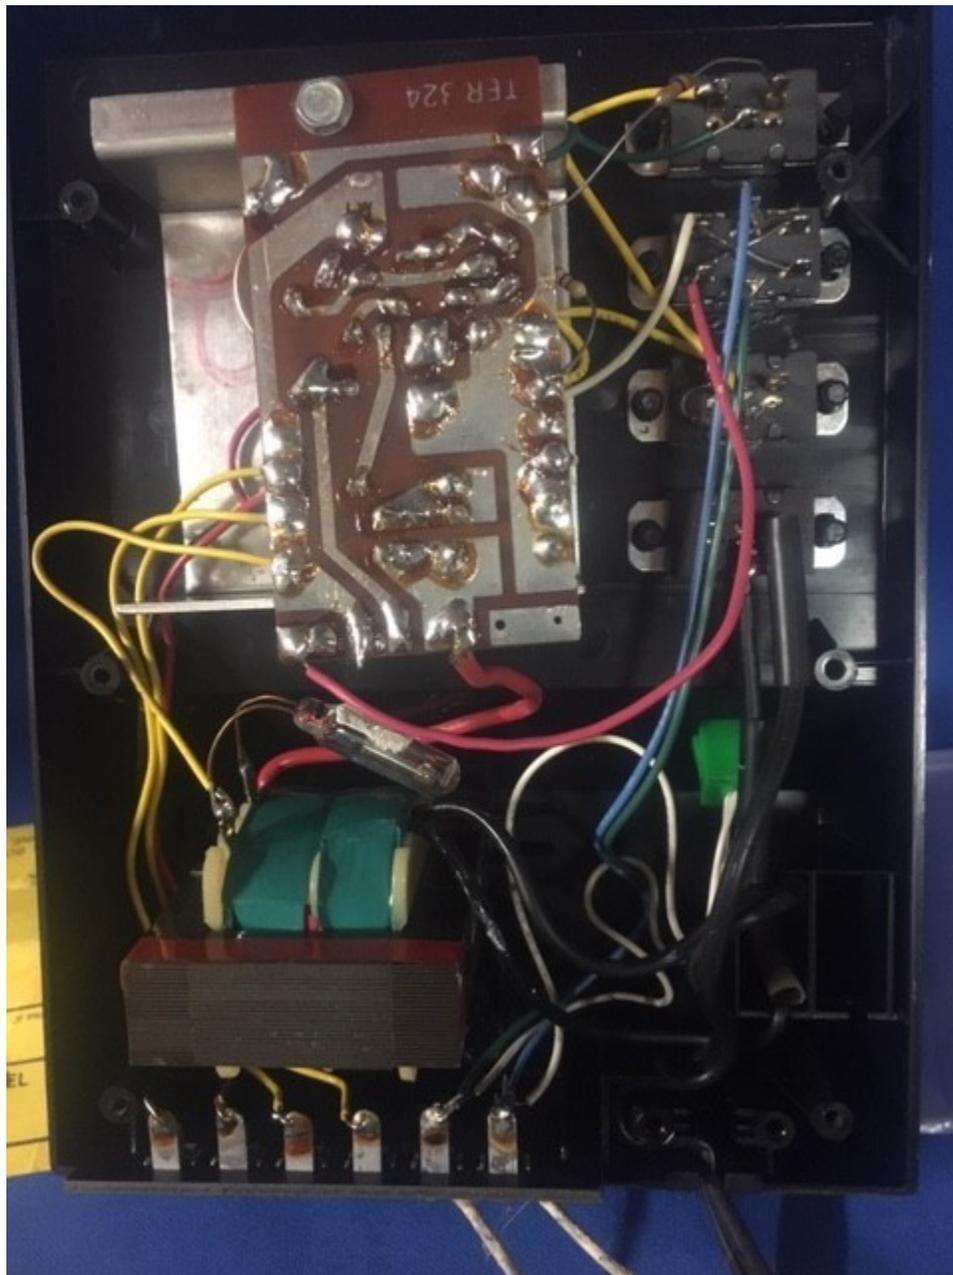
Figure 3: MRC1500 Circuit Board

Failure mode #2 is the "lost zero" symptom where the user cannot completely shut off the throttle and the locomotive continues to creep along at a "zero" throttle setting. This "lost zero" failure mode is due to circuit board leakages most probably due to corrosion between the solder pads. The solution is to open the throttle chassis and wipe down the circuit board/s with isopropyl alcohol and an absorbent pad of some sort (e.g. q-tip). What has happened is that the board processor has not adequately rinsed the board and has left acidic residues that absorb moisture and, bingo, conductive metal films (aka dendrites) form between the adjacent solder traces. As an added safety precaution I recommend that the potentiometer be rinsed off with an electronic circuit cleaner although I doubt that the potentiometer is involved with the "lost zero" failure mode.

Re the above photo: Residual flux is evident as the “brownish” hazy material around the solder pads. It is this residual flux residue that probably causes the “lost zero” failure mode for MRC transistorized throttles.

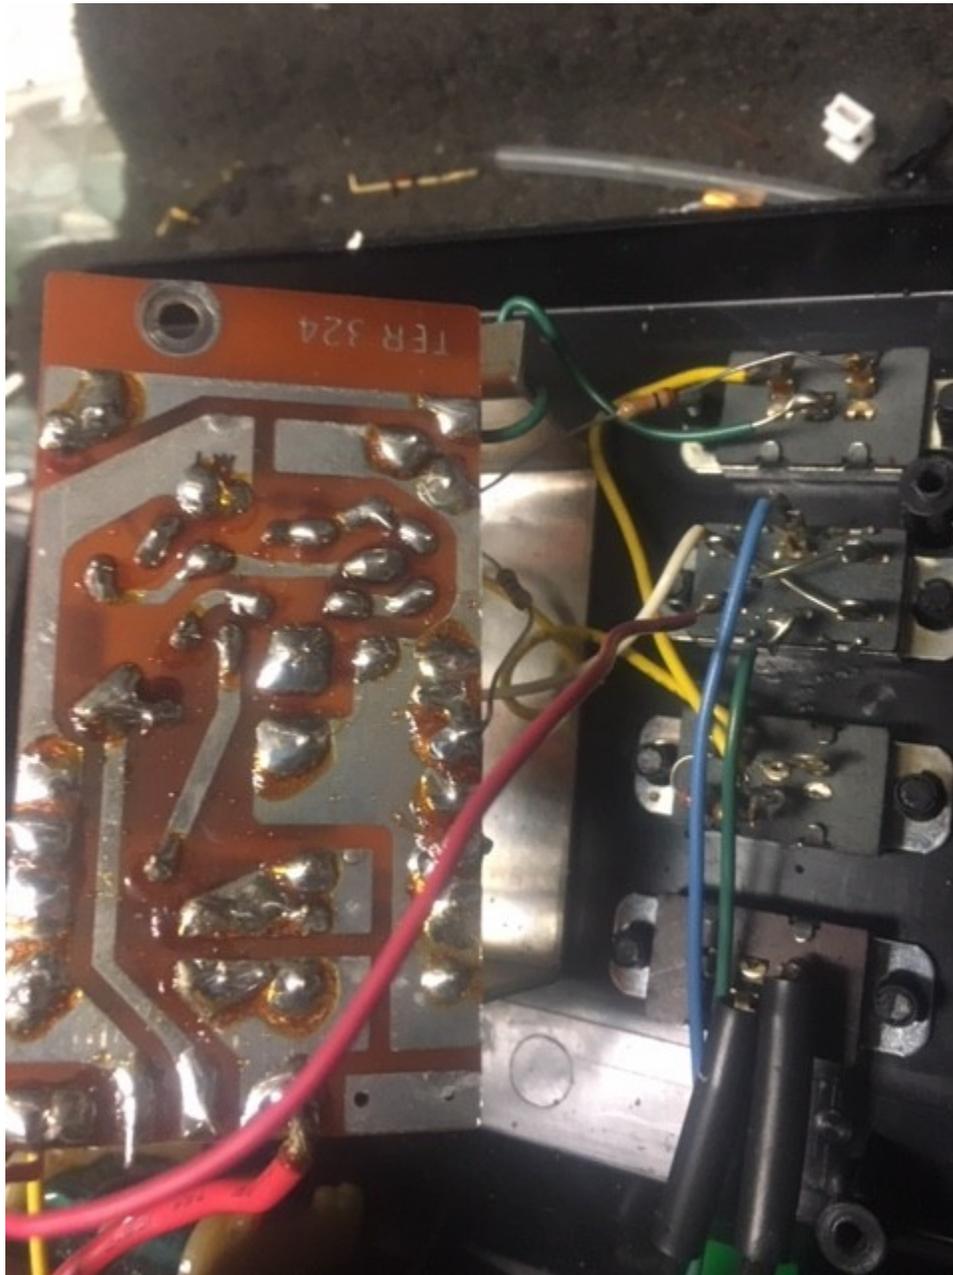
Figure 4: MRC1500 Circuit Board

Re the above photo: The flip side of the circuit board shown in Figure. The residual flux residues are the brown hazy material surrounding the solder pads.

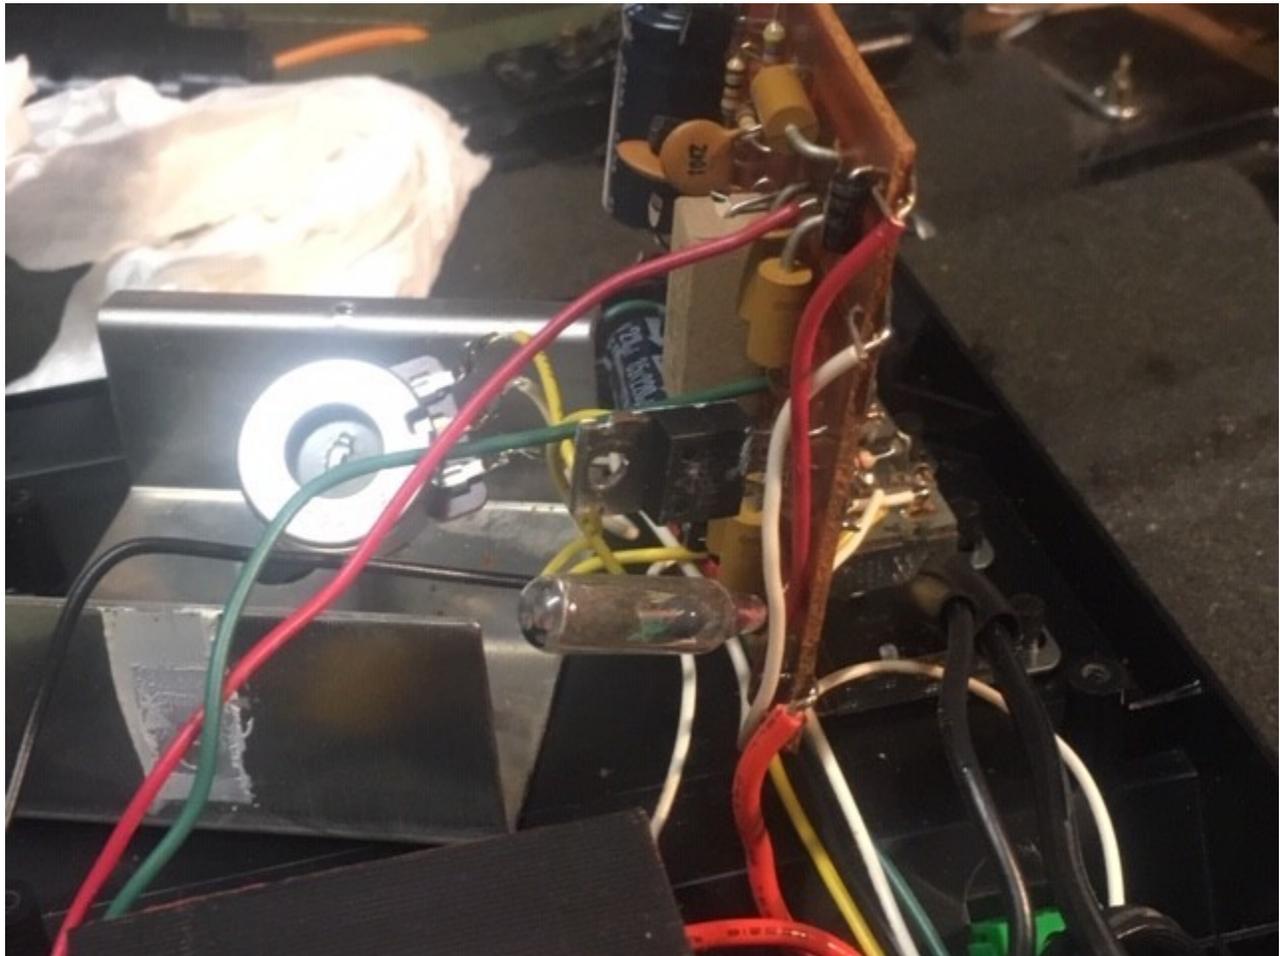
Figure 6: The Encapsulated Mercury Circuit Breaker (front and center)

Re the above: For safety reasons the above glass encapsulated circuit breaker must “open” when the throttle output terminals are connected to a short.

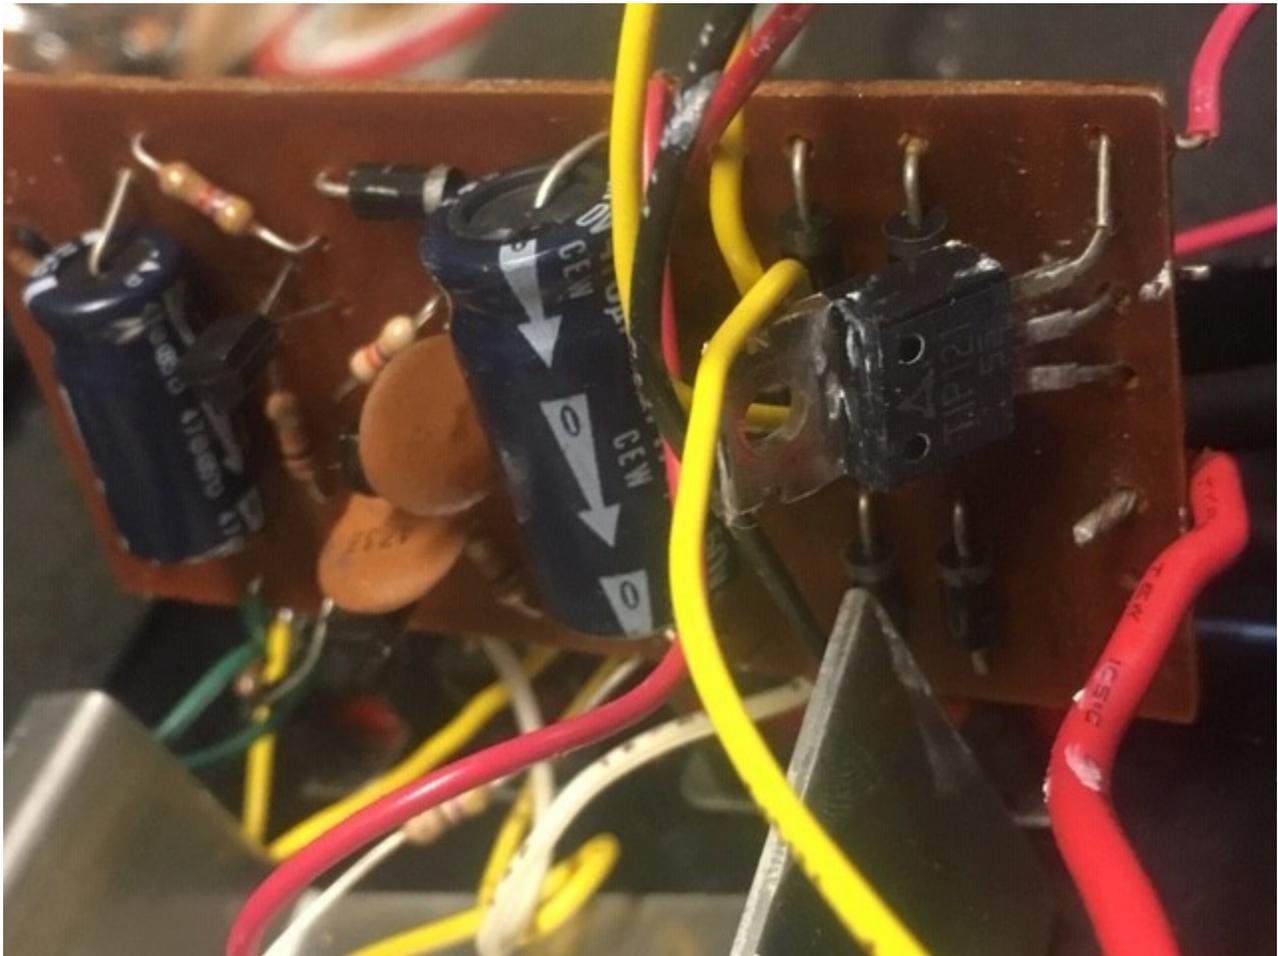
Figure 7: MRC1500 Circuit Board w/Darlington Tx and Electrolytic Capacitors

Failure mode #1 is a shorted output Darlington transistor. The failure symptom for a shorted Darlington transistor is that locomotives run at maximum velocity regardless of throttle setting. The solution is to simply replace the Darlington transistor. Mr. David Bodnar has a presentation on how to (http://www.trainelectronics.com/MRC_6200/) do the Darlington replacement for the MRC6200 throttle. The 50 watt MRC6200 utilizes two Darlington transistors wired in parallel so as to provide enough current for large scale (e.g. LGB) model locomotives. Typically only one of the two Darlington transistors fails in the 6200. The Tech II series (1400, 1500, 2400, and 2500), 9370, Tech 3, and Tech4 throttles have single Darlington transistor outputs and the replacement procedures are similar to that described by Mr. Bodnar.

To be sure there are other possible failure modes. The circuit breaker may fail and need replacement but that is a safety issue and not a functional failure (see David Bodnar's web site-referenced above). The electrolytic capacitors (those blue cylinders) are "wet" devices and, over time, those wet paper dielectric films can dry out and fail. Look for a visible "rupture" on the cover of the

electrolytic capacitor. Electrolytic capacitor replacement is relatively easy to do even for a novice solderer.
