MRC Model Railroad Transistor Throttle Repair

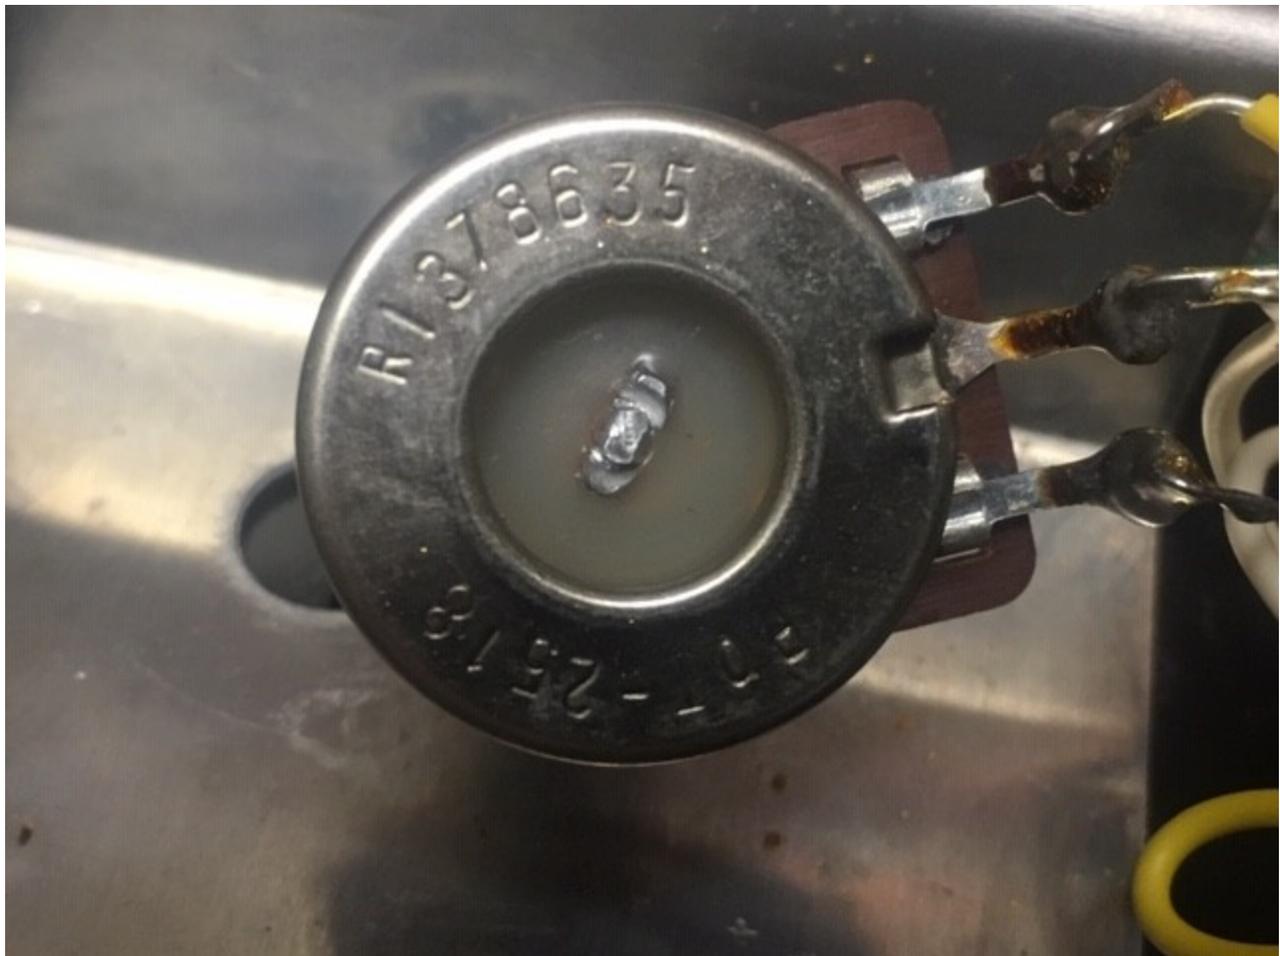
Figure 5: 2500 Ohm Potentiometer-MRC6200

Re the above photo: The above 2500 ohm potentiometer is similar to potentiometers utilized MRC transistorized throttles. During any repair actions it is advisable to clean these potentiometers with spray of electronic cleaner.
