Pennsylvania Rail Road F-Units

Models and Commentary by Les Souder

Edited by Henry Kramer

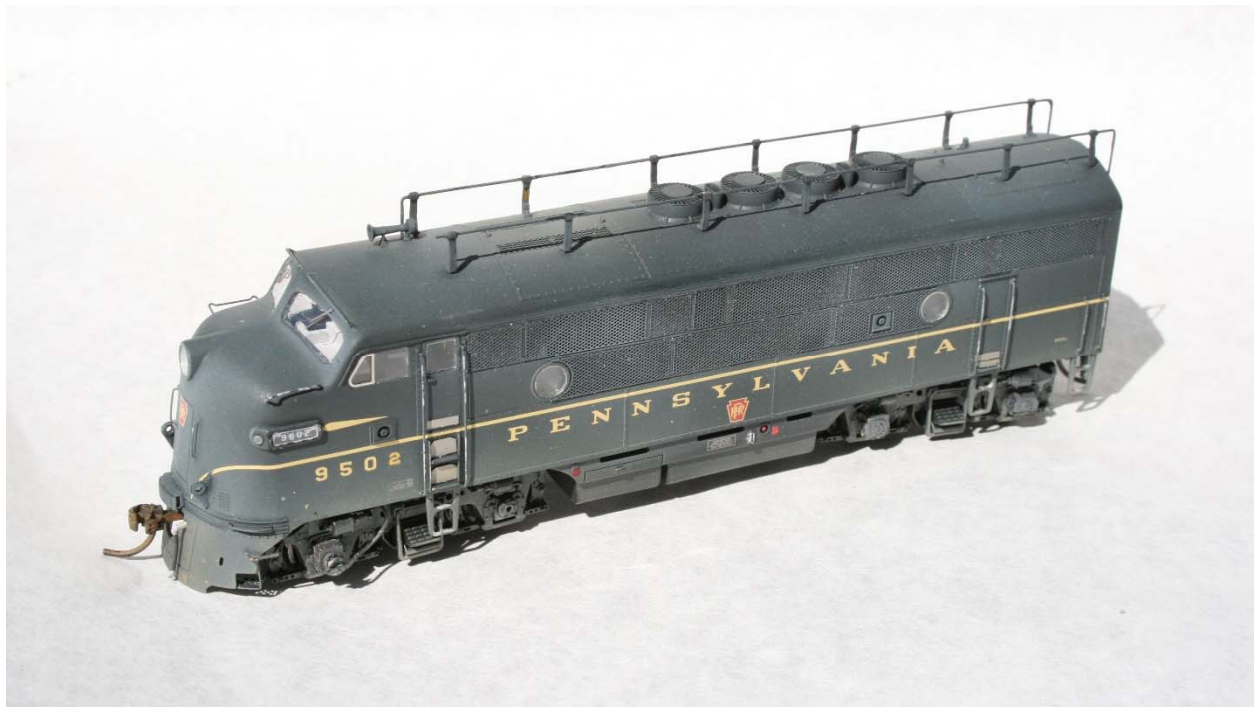
Figure 1A – F3 Phase 2: These engines had high fans and a chicken wire grille between the portholes on the “A” units. They went into service in 1946 and were the first F3 engines that the PRR received after WW2. The models are decorated as they would have been seen in 1955.

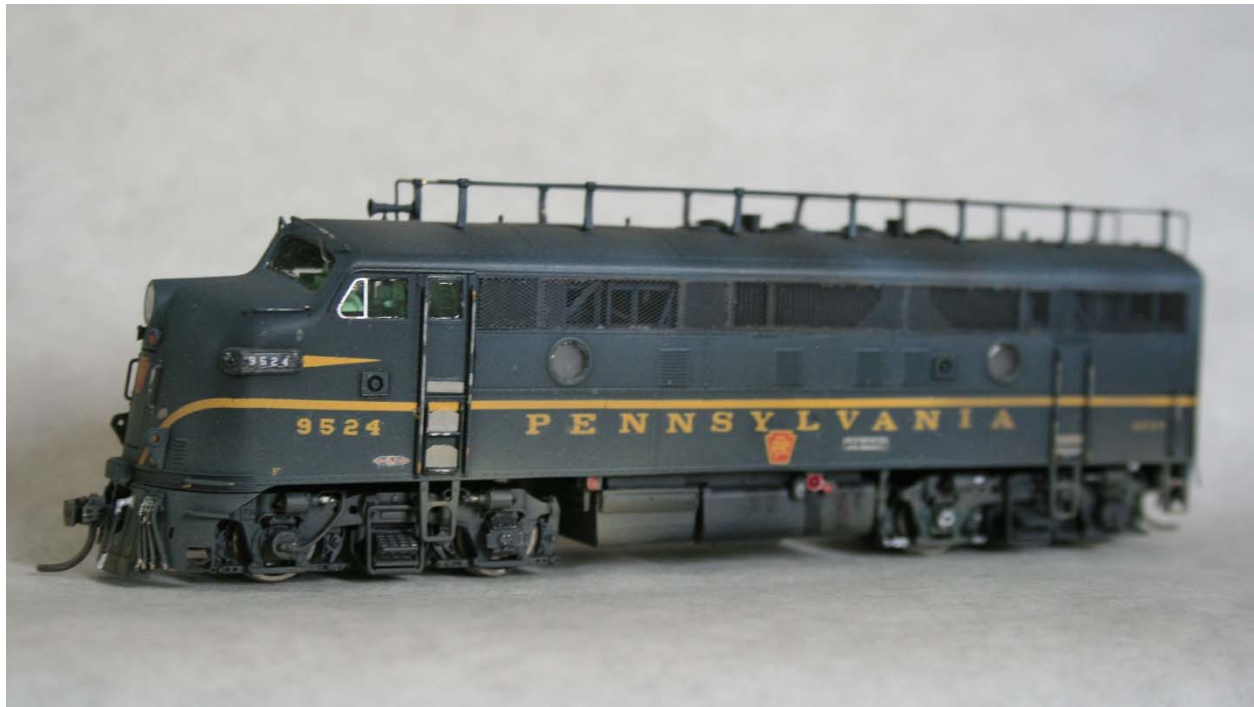
Figure 2 – F3 Phase 3: These engines have low fans and louvers between the portholes. This model is decorated as it would have been seen in 1960.

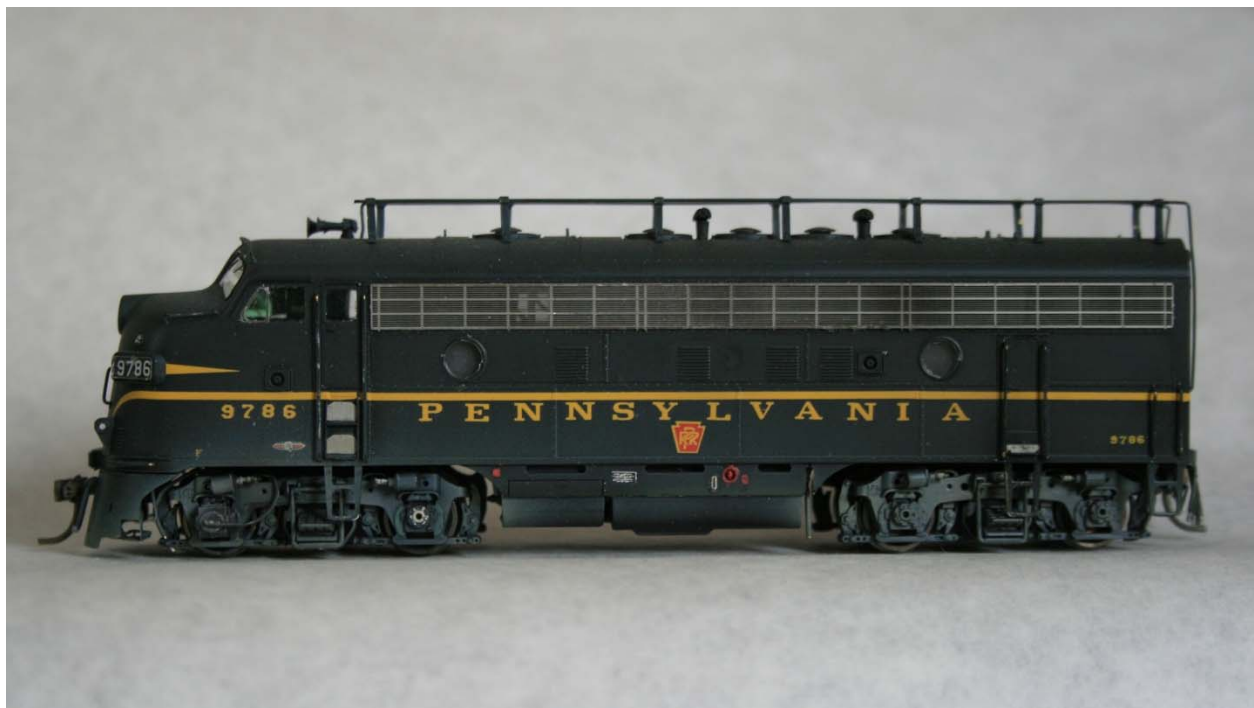
Figure 3A – In 1949 the PRR started using F7s. These engines represent PRR F7 engines as they would have been seen in 1956.

Figure 4A – This F7 “A” unit engine is configured as it would have looked in 1964. The difference between this unit and the one in Figure 3A is that the fuel tank skirting has been removed as well as the addition of a nose ladder. Also, MU connections on the nose were added. These changes and others were mandated by the Federal Railroad Administration (FRA).

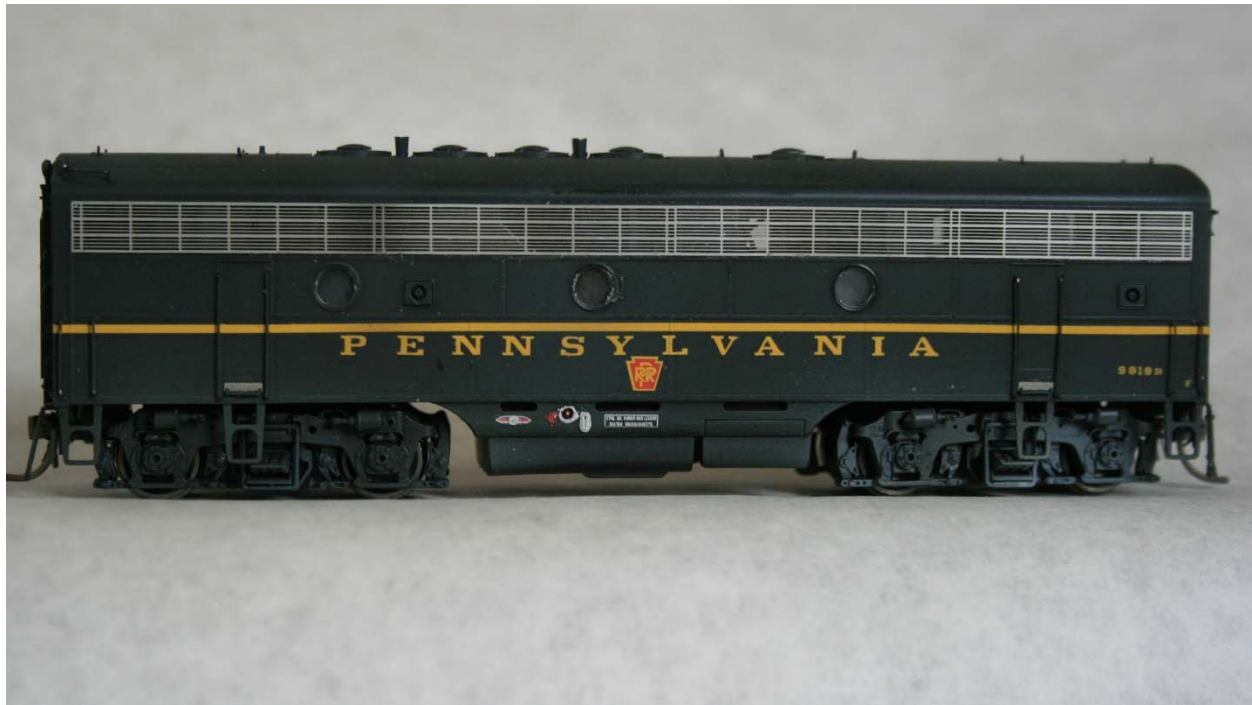
Figure 3B – This is a PRR F7 “B” unit as it would have been seen in 1956.

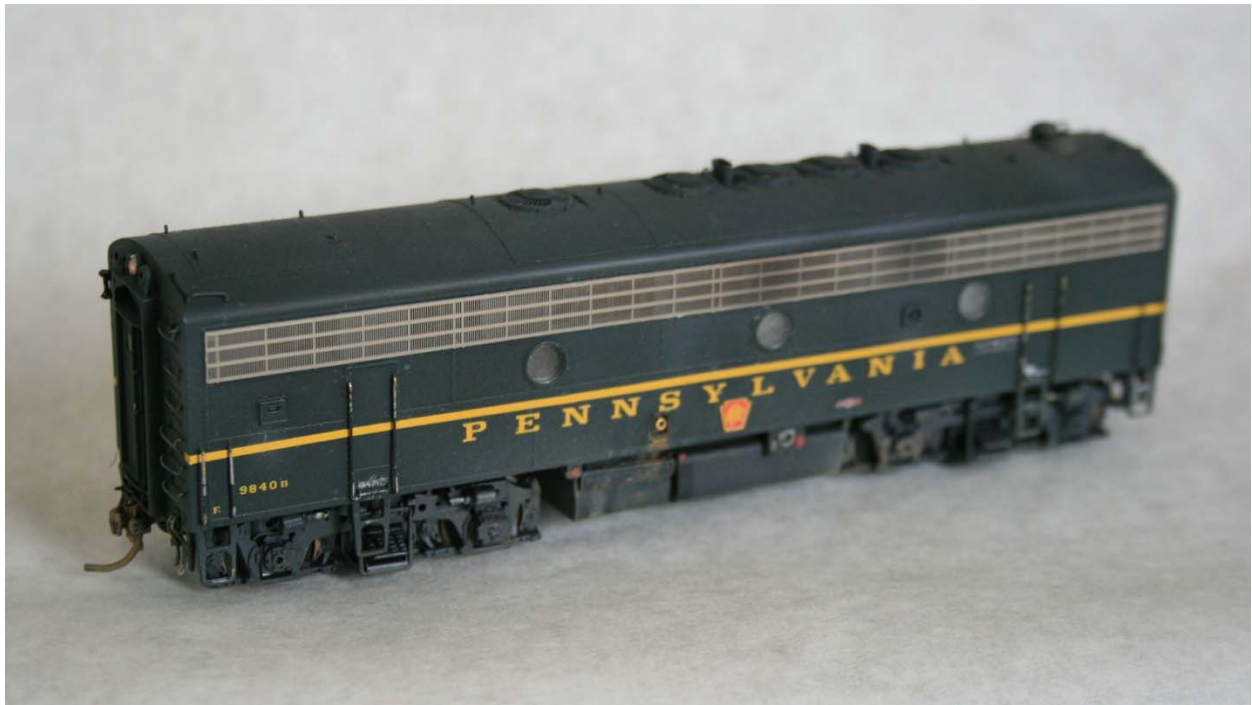
Figure 4B – This F7 "B" unit configured as it would have looked in 1964.

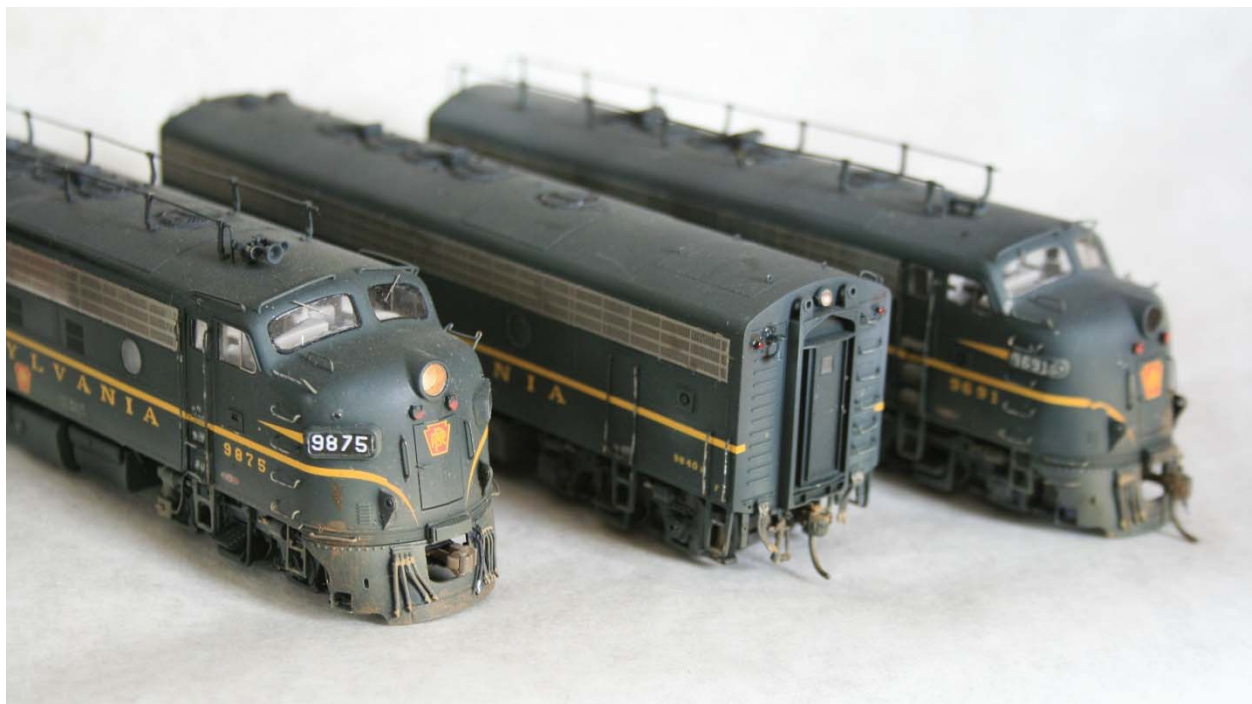
Figure 4C – Note the addition of MU connections.

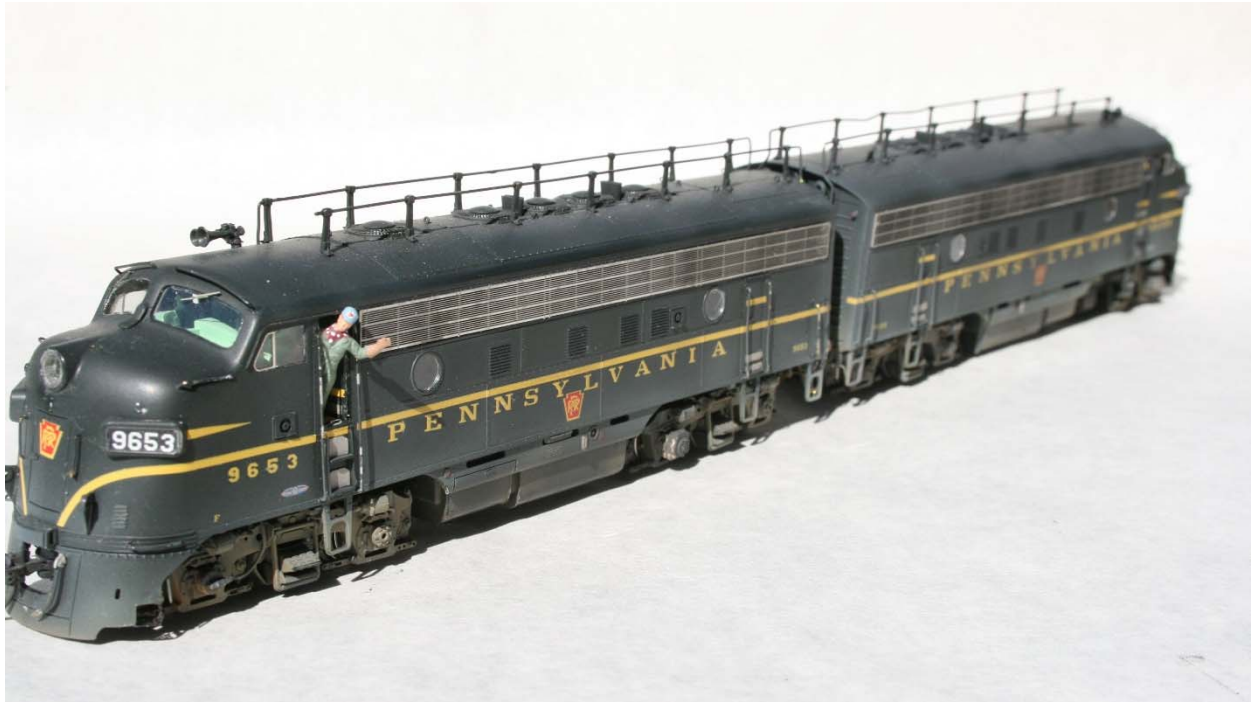
Figure 5A – These EH-15 engines are decorated as they would have been seen in 1957. EH-15 engines can be identified by an extra stripe on the door. This stripe was added to alert the engineer that they were lower geared engines. Normally these engines were usually in the front of a consist.

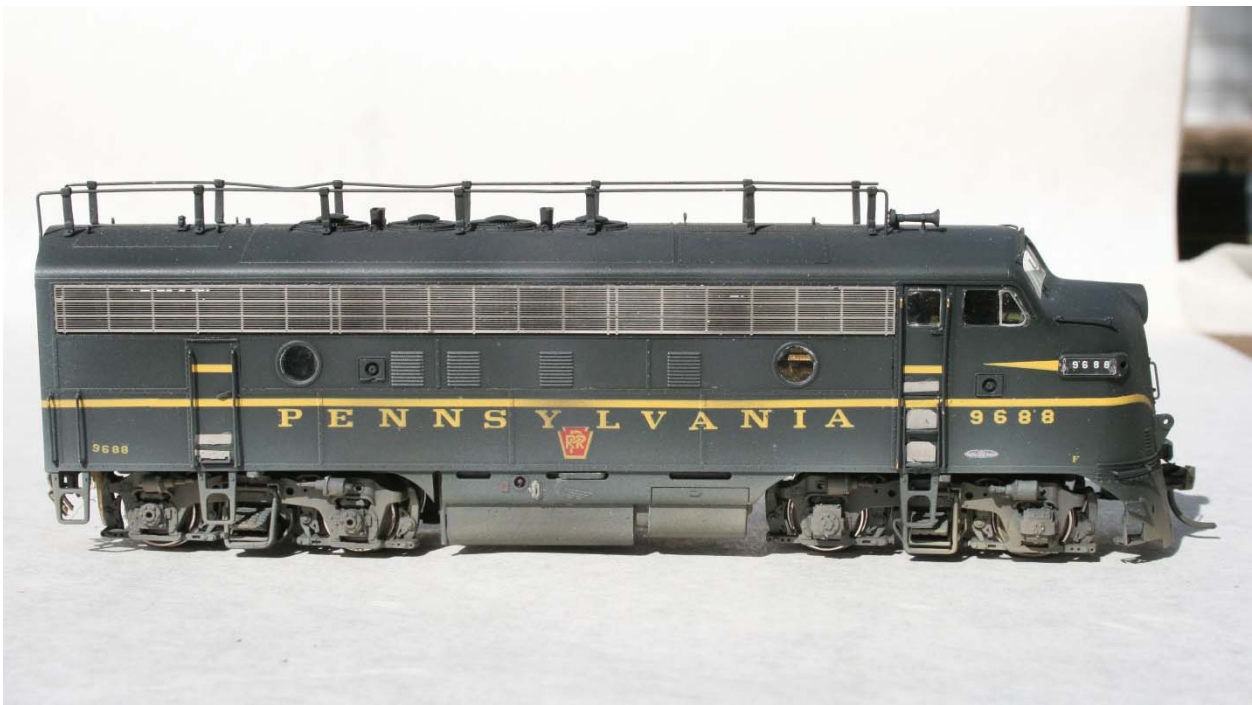
Figure 5B – Note the extra stripe on the door of this EH-15 engine.

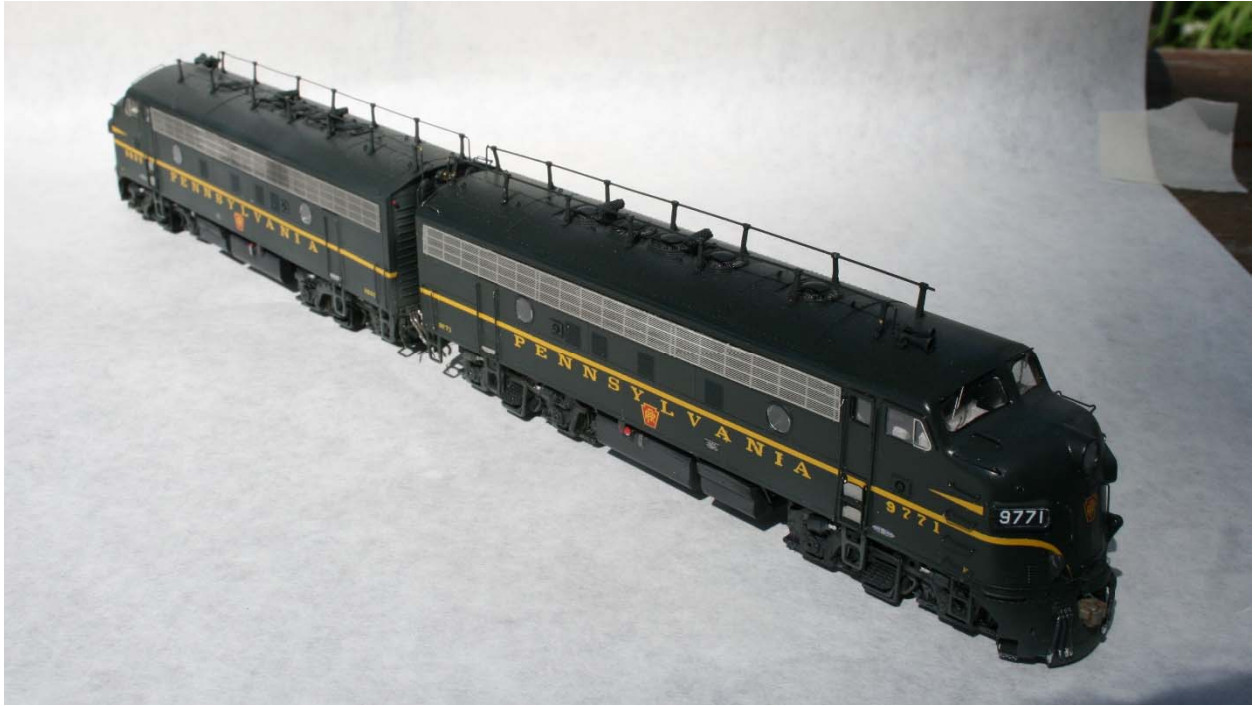
Figure 6 – These F7 engines are decorated as they would have been seen in 1960.

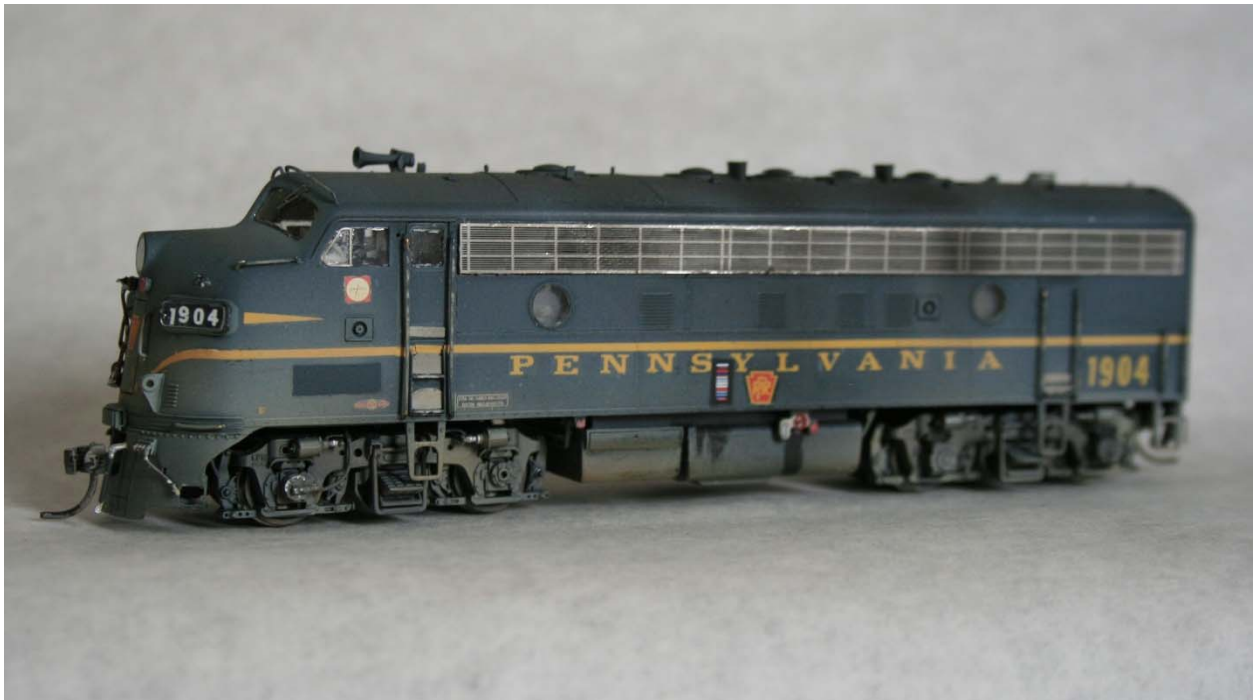
Figure 7 – This F7 engine is decorated as it would have been seen in 1965. Note that the radio telephone antennas have been removed and a “DOT” has been added on its nose. This “DOT” signifies that a radio has been installed in this unit.

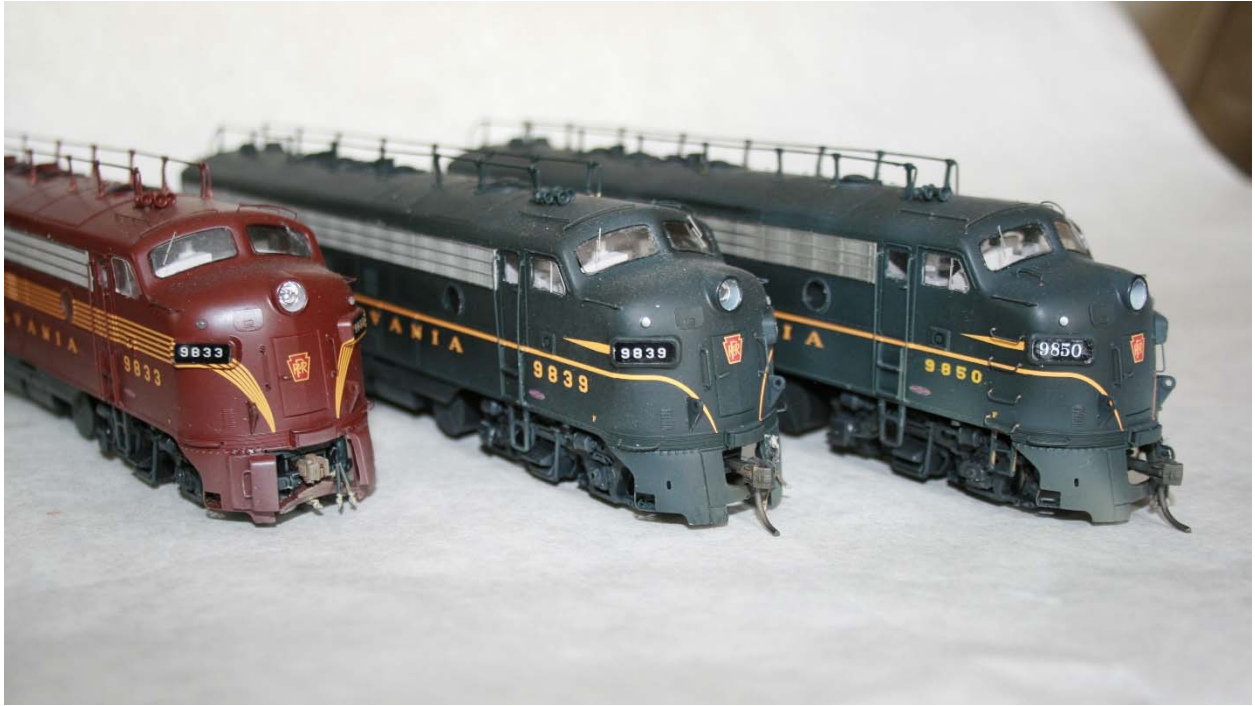
Figure 8 – The PRR primarily used FP-7s as freight engines. The above FP-7 engines are painted as they would have been seen when they were delivered in 1955. The PRR took delivery of six red units (two sets of ABA engines) out of the 40 engines that were delivered that year. PRR passenger engines in the 1940s were painted green with five yellow stripes. In 1952 this paint scheme was changed to red engines with five yellow stripes.

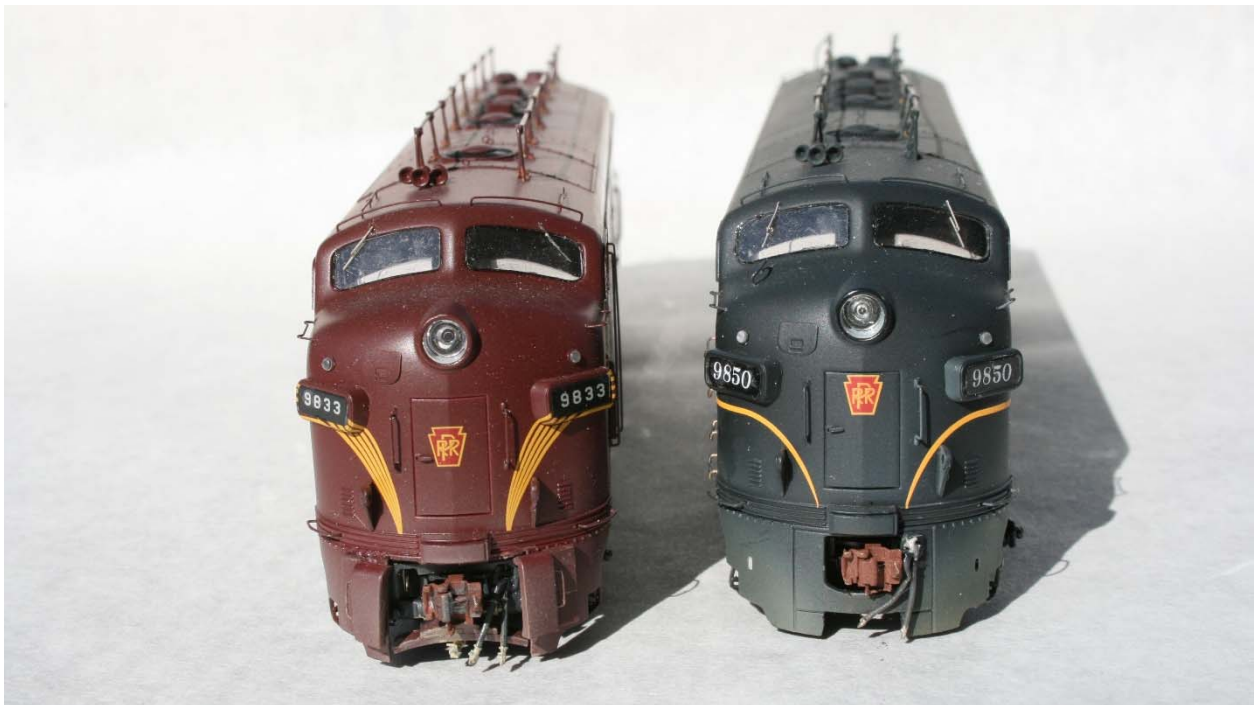
Figure 9 – F7 engines were delivered with nose coupler covers. The engine of the left has open coupler covers. When there were maintenance problems with the coupler covers rather than repairing them they were simply removed. The green unit on the right has had its coupler covers removed.

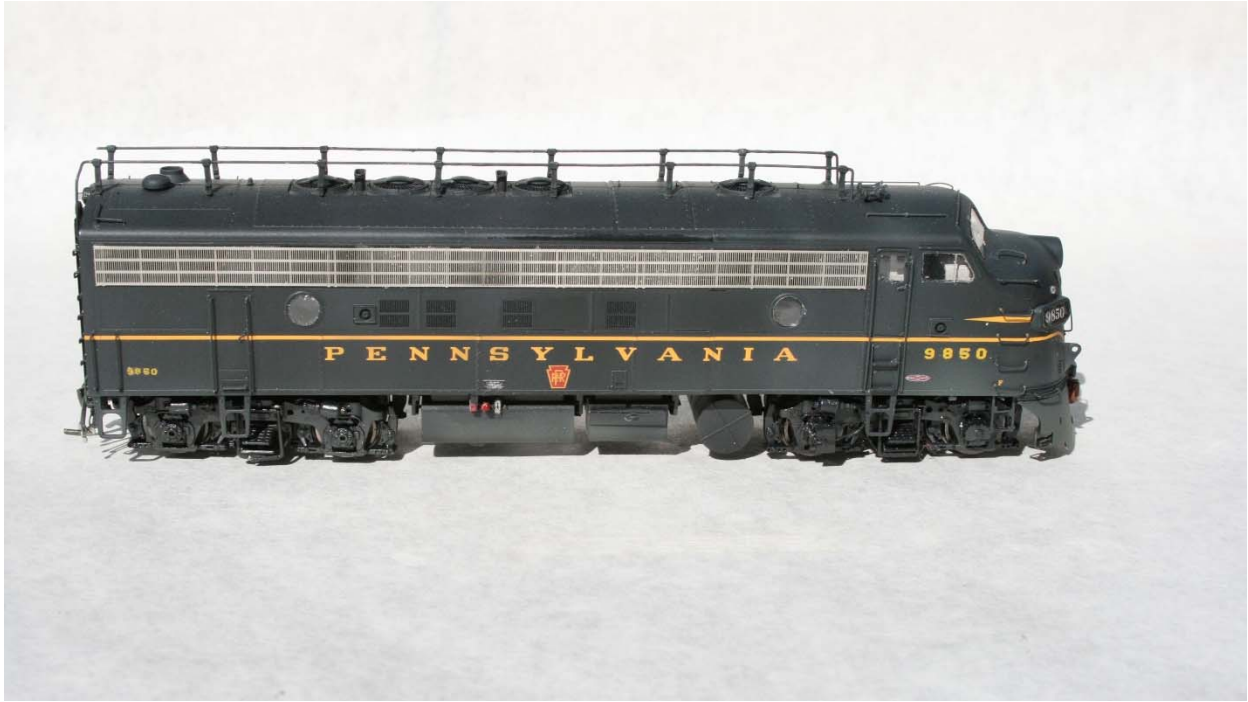
Figure 10 – This EFP-15 engine is painted as it would have looked in 1959. Note that the fuel tank skirt has been removed and the addition of a water tank. Ladders have also been added in the front and rear. The addition of a rear ladder was mandated by FRA in 1959.
